Service Bulletin

SAFETY RECALL

2002-2004 GL1800/A

Linked Braking System (LBS) Proportional Control Valve (PCV) Leakage

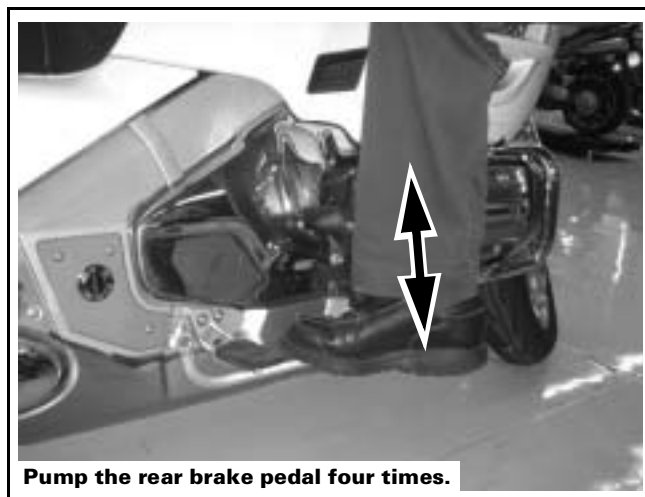
1. Pump the rear brake pedal four times.
 - If the brake pedal feels spongy, bleed the brake system per the Service Manual. After verifying proper brake system operation, proceed to step 2 below.
 - If the brake pedal does not feel spongy, proceed to step 2 below.

2. Place the motorcycle on its side stand, with the handlebars in the **full left position**. Lock the handlebars.
3. Place a scissor jack directly under the left front brake caliper as shown in the illustration. To avoid damage to the caliper, place a protective piece of rubber (such as a

piece of inner tube) between the caliper and the jack.

Wind up the jack until the front wheel is approximately 15 mm off the ground.
