Service Bulletin

American Honda Motor Co., Inc.

SAFETY RECALL

2006-2010 GL1800-8A AIRBAG MODULE REPLACEMENT

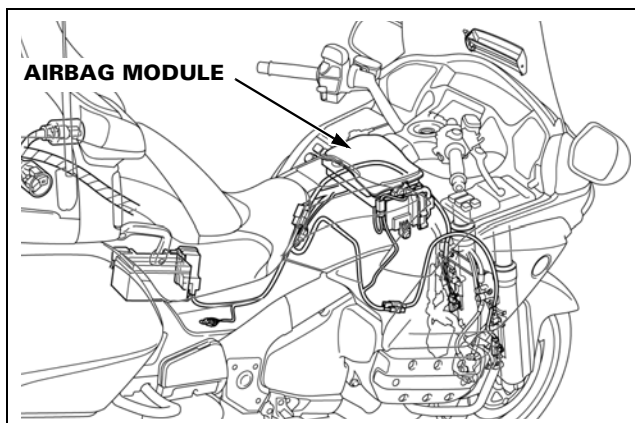
According to National Highway Traffic Safety Administration (NHTSA) equipment defect notifications (16E-042 and 16E-043) filed by Takata, the propellant in some of the subject inflators may degrade over time, which could lead to over-aggressive combustion in the event the airbag is activated during a crash. Overly aggressive combustion creates excessive internal pressure within the inflator, which may cause the inflator body to rupture upon deployment.

A redesigned airbag module is available to correct this condition.
