Service Bulletin

SAFETY RECALL

2002-2004 GL1800/A

Linked Braking System (LBS) Proportional Control Valve (PCV) Leakage

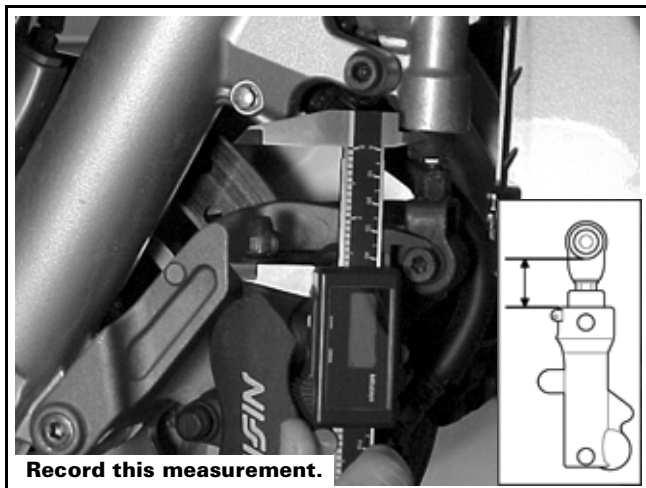
4. Measure the distance from the secondary master cylinder piston mounting bolt to the edge of the secondary master cylinder body (rod length of the secondary master cylinder). **Record this measurement.**
 - If the measured length is **30.3 mm**, replace the PCV per the Service Manual. (This length indicates the unit's secondary master cylinder is fully stroked, which means there is no hydraulic brake pressure acting on the PCV.) After replacing the PCV, proceed to the IDENTIFICATION section of this Service Bulletin.
 - If the measured length is **longer than 30.3 mm**, proceed to step 5 below.
